Manhole Inspection Summary

Manhole # S35MM1001MH

Insp Date: **3/13/07 1:37 PM**

Location Address: **4501 UNDERWOOD RD**

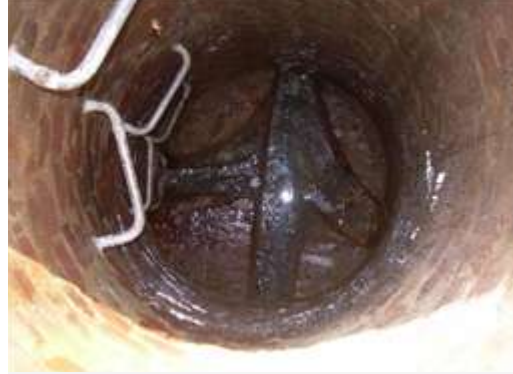
Top View

Corroded steps. Bench and Channel debris.

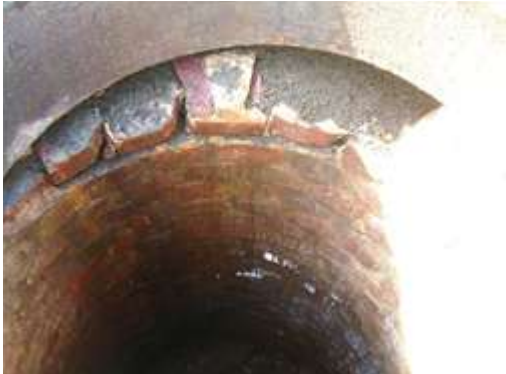
Defect

Frame leaks. Frame offset. Adjustment deterioration, loose brick and infiltration.

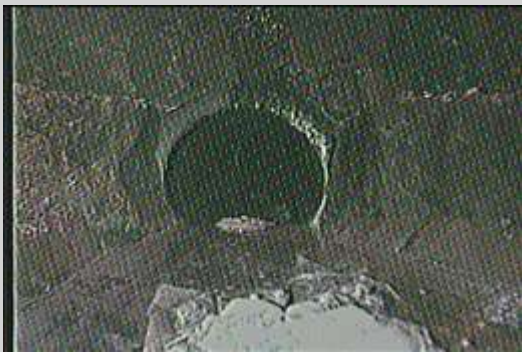
8 in. Circular Gravity Sewer Pipe Out @ 12 O'Clock

Infiltration: **Evidence** Pipe Seal Cond: **Cracked**

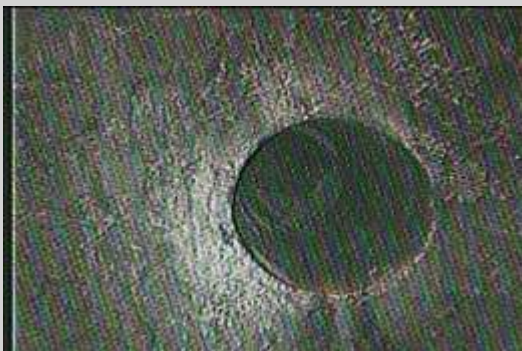
8 in. Circular Gravity Sewer Pipe In @ 3 O'Clock

Infiltration: **None** Pipe Seal Cond: **Unknown**

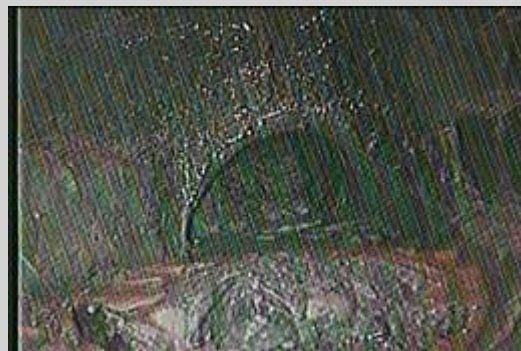
Drop In @ 3 O'Clock

Drop Condition: **Open**

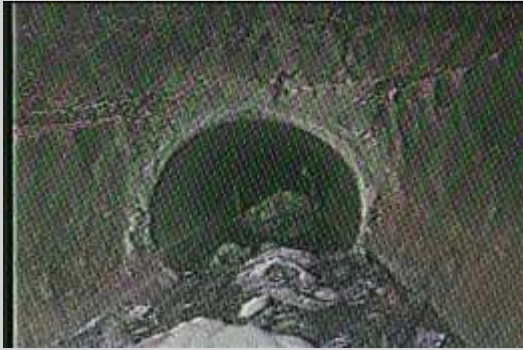
Pipe In @ 6 O'Clock

Deposits: ☐ None ☒ **Mud** ☐ Sludge ☒ **Debris** ☐ Grease

Silt Depth: **1** (in.) Deposits Extent: **Light**

Infiltration: **None** Pipe Seal Cond: **Cracked**

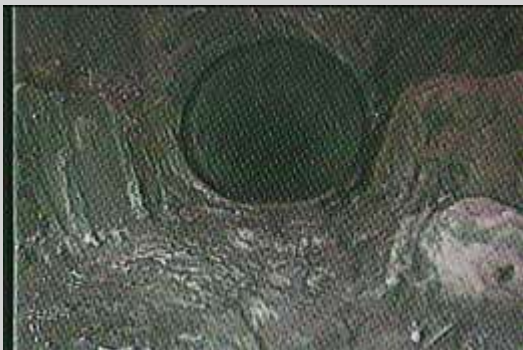
Pipe In @ 9 O'Clock

Infiltration: **Evidence** Pipe Seal Cond: **Cracked**
